BioMax Environmental
Environmental Consulting and Industrial Hygiene Services

August 26th, 2008

Post Mitigation Assessment Report
Department of General Services Board of Equalization Building
Break Rooms 2202, 2223, 2224, and 22 Men's and Women's Restrooms
450 N. Street
Sacramento, California

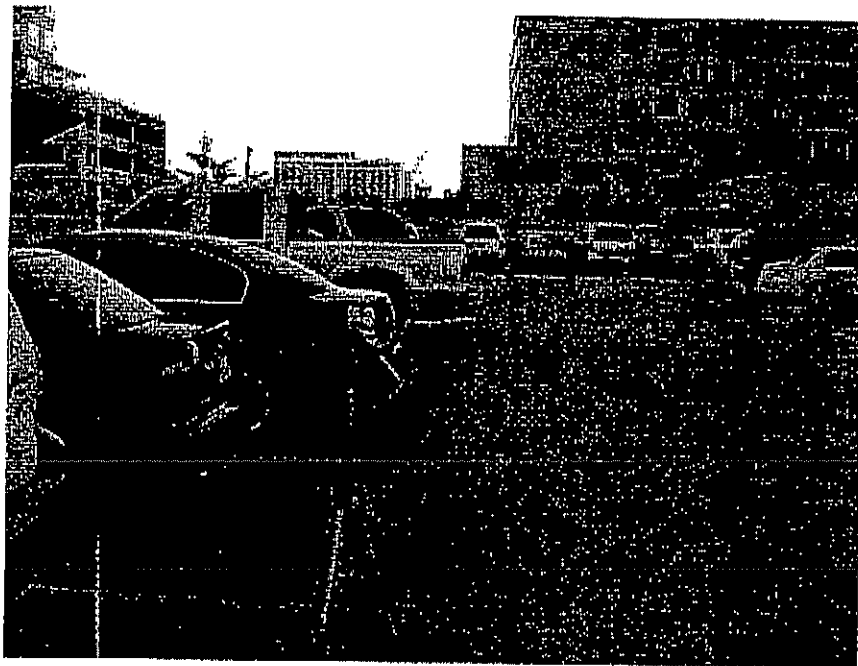
- 1) Image of ambient air sampling location at rooftop of garage structure adjacent to the BOE building (Subject Building) located at 450 N Street, Sacramento.

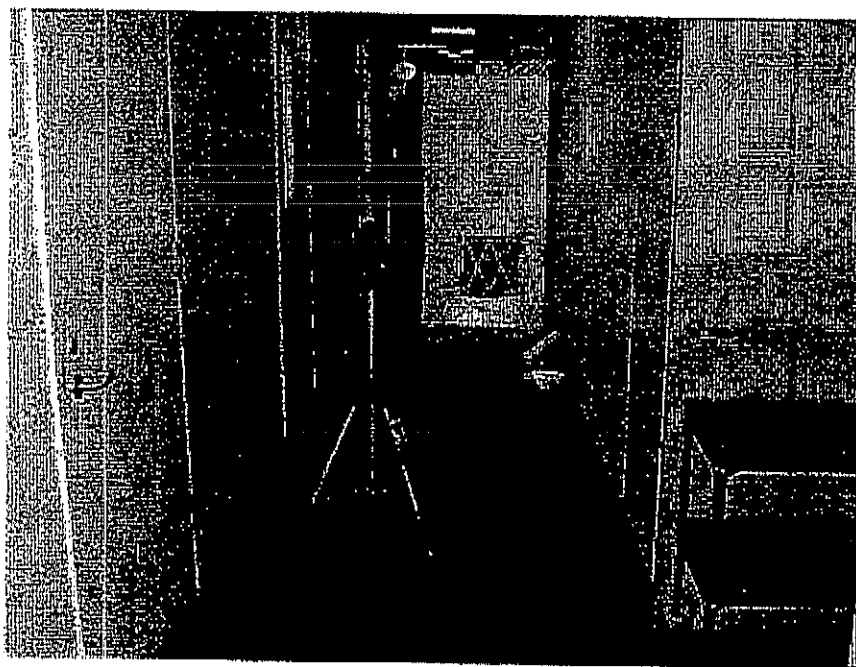
- 2) Image of air sampling equipment located within hallway of 22nd Floor near 2202 break room containment.

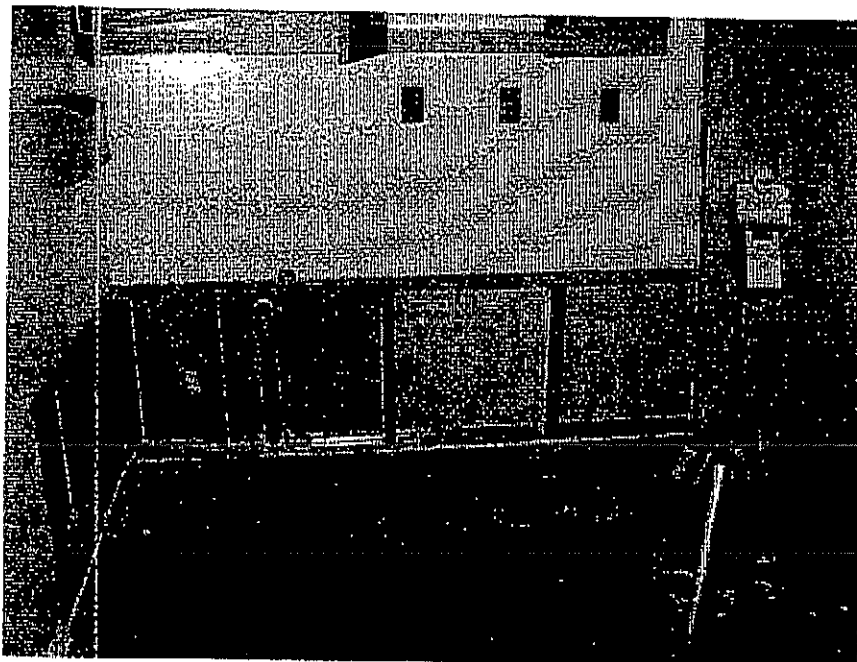
- 3) Image of wall removal delineation and air sampling activity performed within Break Room 2202 at time of assessment.

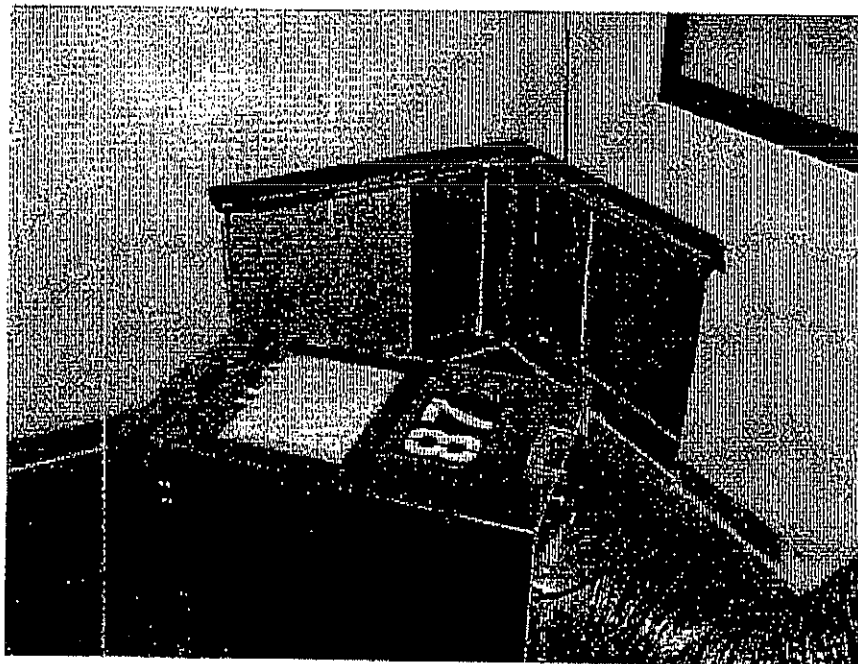
- 4) Image of adjacent wallboard removal delineation performed within Break Room 2202 as part of mitigative activity.

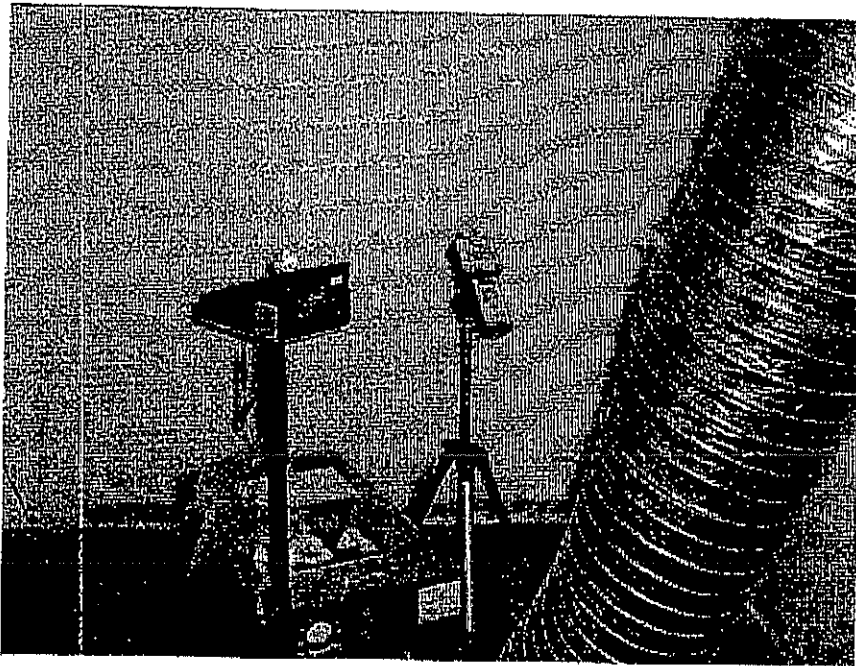
- 5) Image of BioMax and HTI air sampling equipment oriented within Break room 2223 at time of assessment.

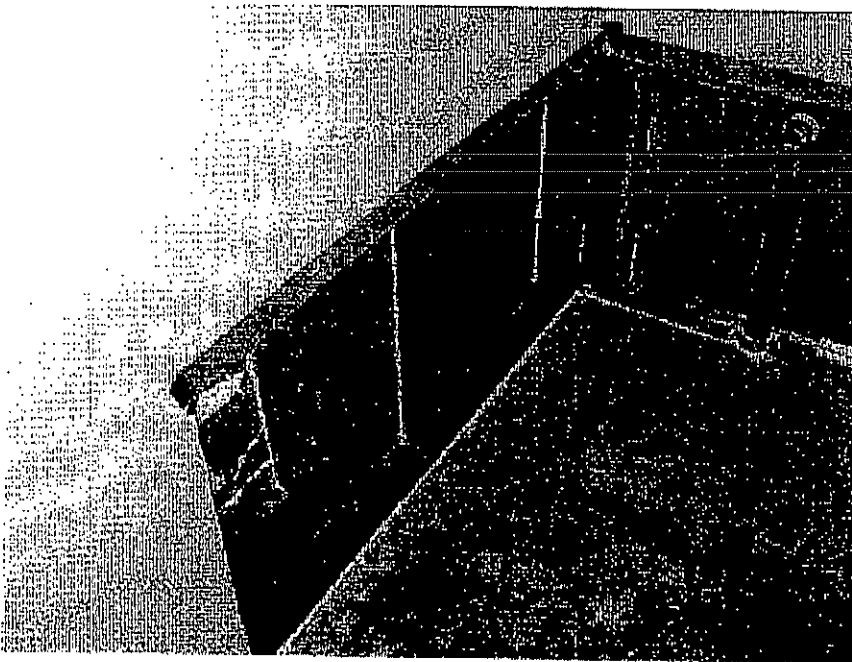
- 6) Image of wallboard removal delineation performed within 2223 at time of assessment.

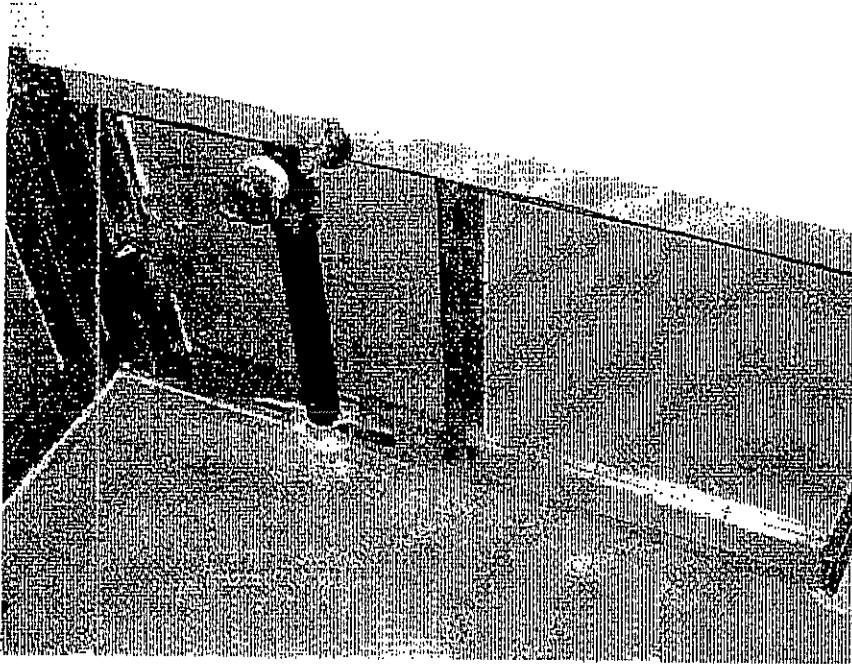
- 7) Additional perspective image indicating extent of wallboard removal performed within break room 2223 as part of the mitigative activity.

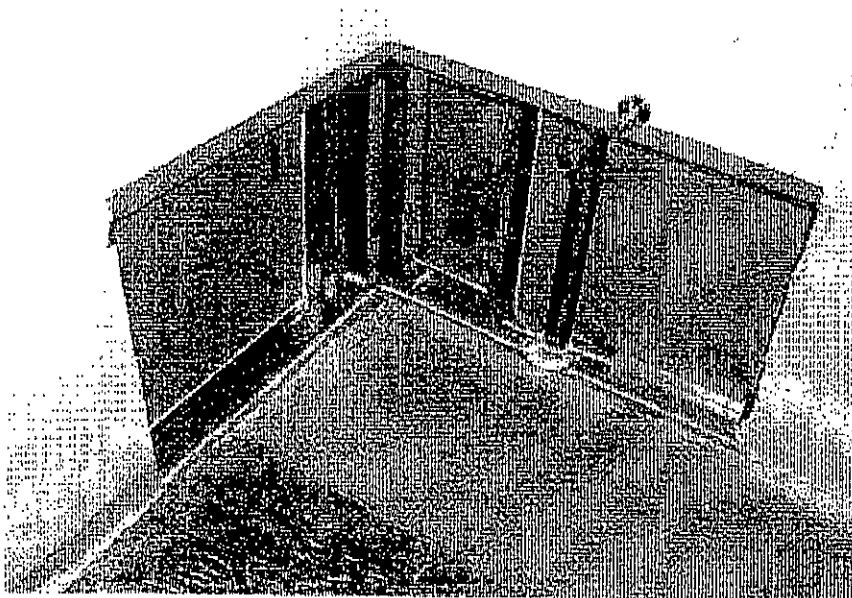
- 8) Image of wallboard removal delineation performed within Employee Lounge (Break Room 2224) as part of the mitigative efforts.

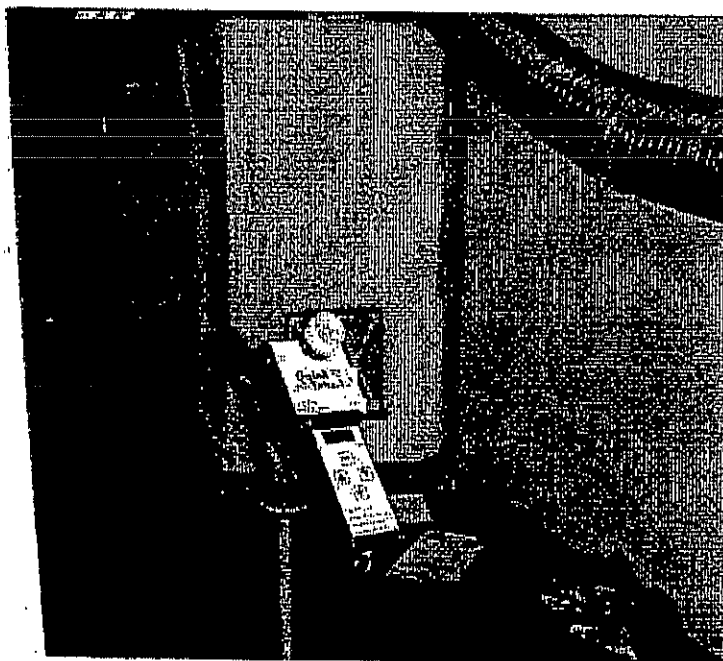
- 10) Image of air sampling activity performed in hallway adjacent to 2223 and 2224 containment areas.

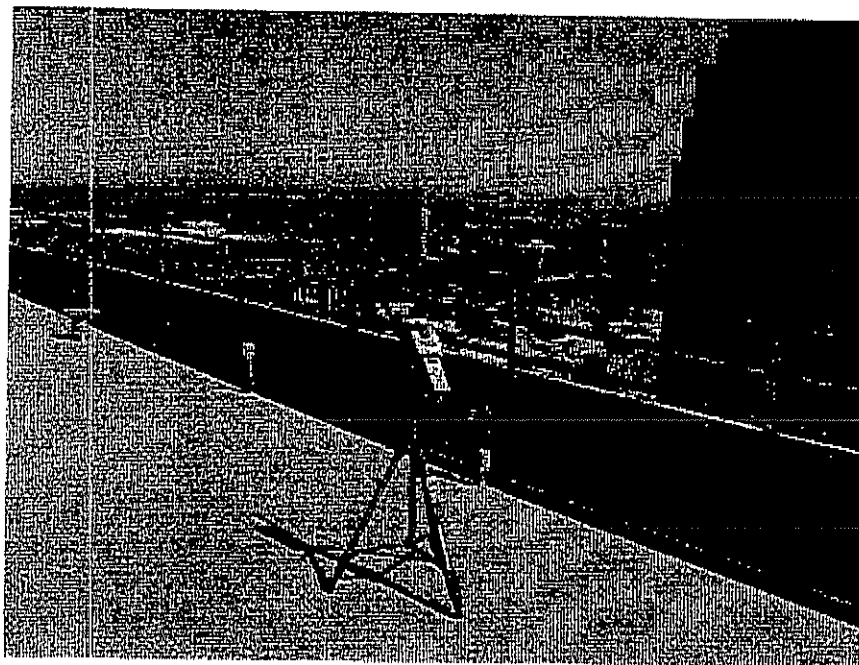
- 11) Image of ambient air sample location on 23rd floor northern balcony following the sample collection of interior samples.

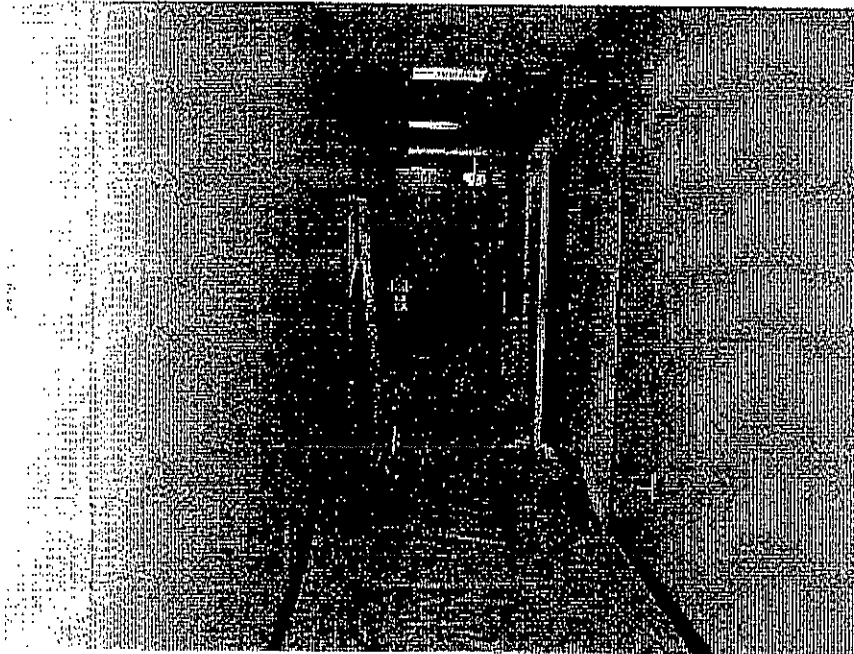
12) Image of air sampling performed within hallway near men's restroom area at time of assessment.

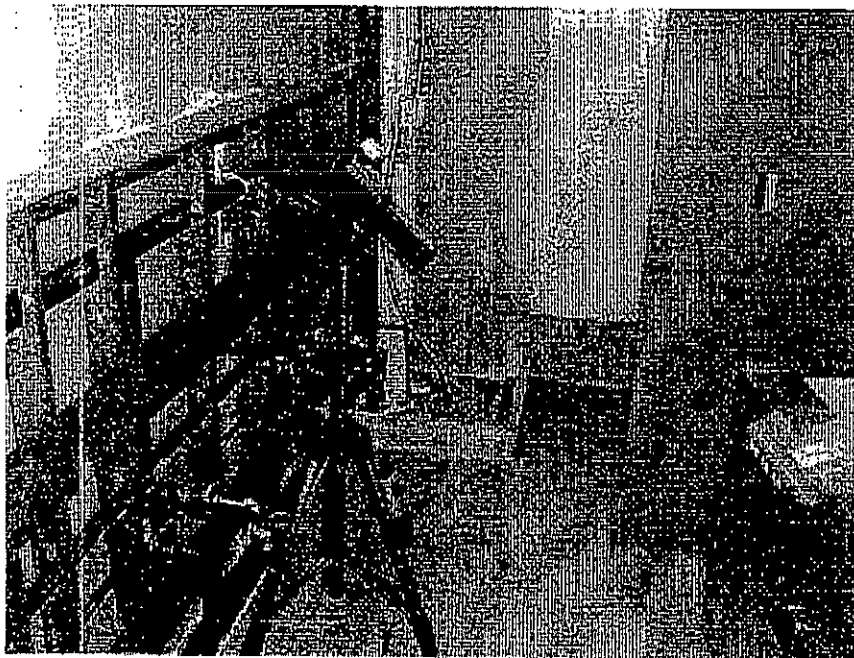
13) Image of wallboard removal and exposed plumbing within men's restroom area following mitigative activity.

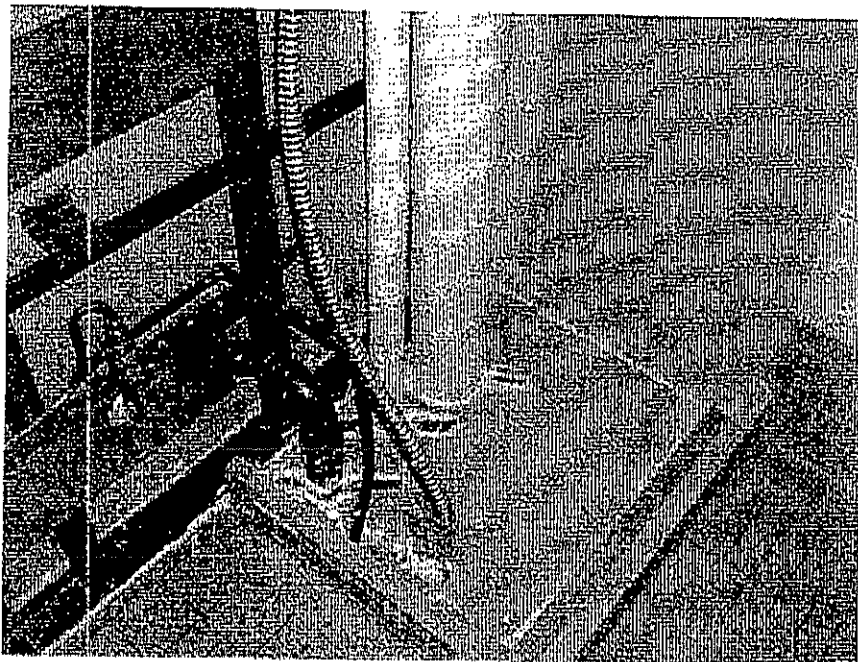
14) Close up image of paper towel chase and interior plumbing systems located to the right of sink area within men's restroom following mitigative activity.

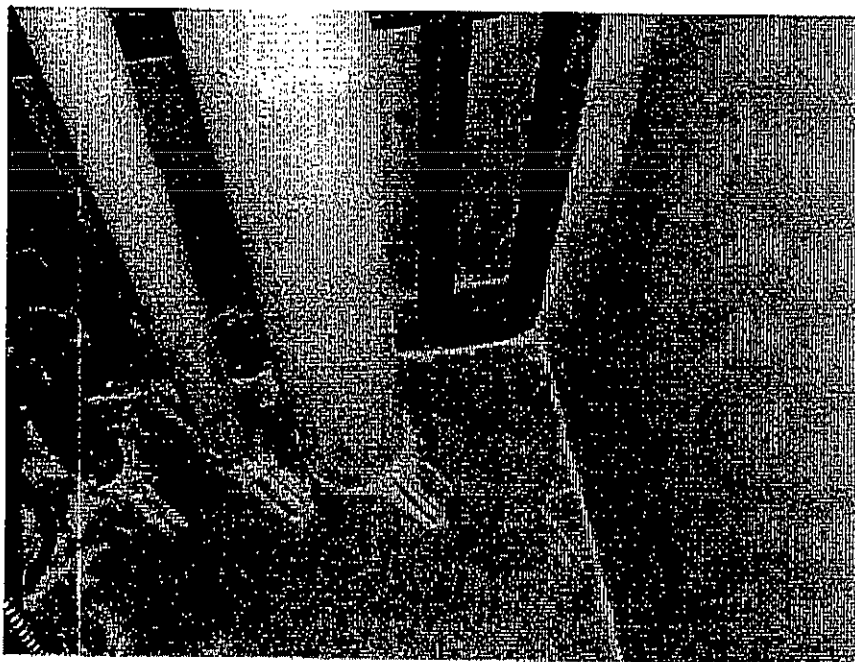
15) Close-up image of wall surface behind right-side paper towel cavity. Noted absence of elevated staining present on wall surface leading to elevator shaft.

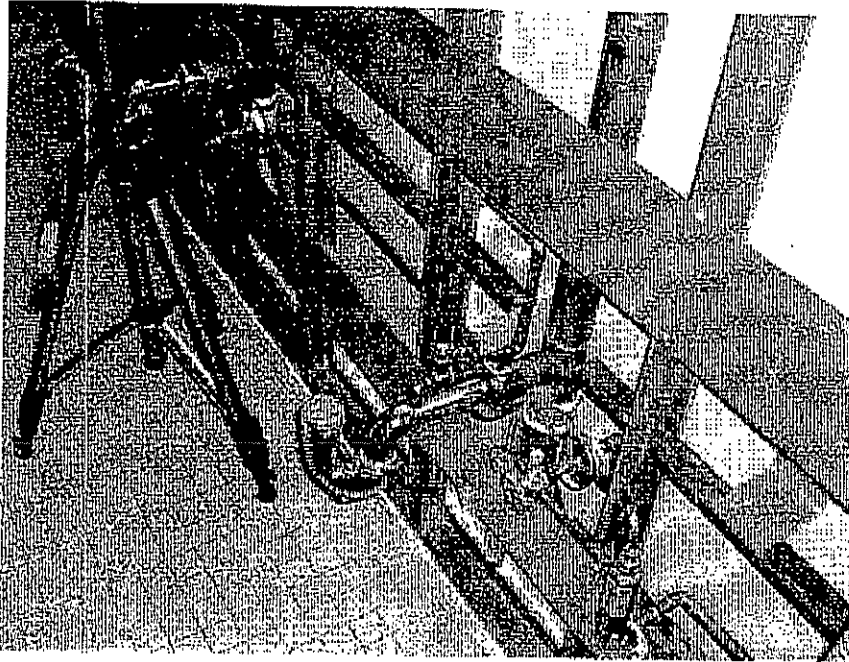
16) Close up image of exposed plumbing and metal framing located at sink area within men's restroom following mitigative removal.

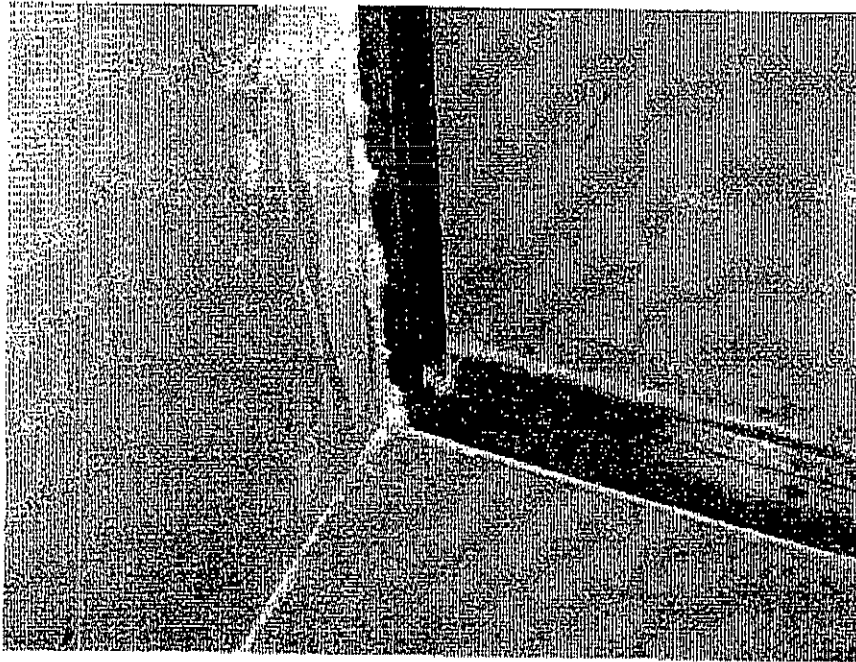
17) Close-up image of wallboard material to left side of prior sink cabinet location. Absence of elevated staining present on wallboard adjacent to elevator shaft system.

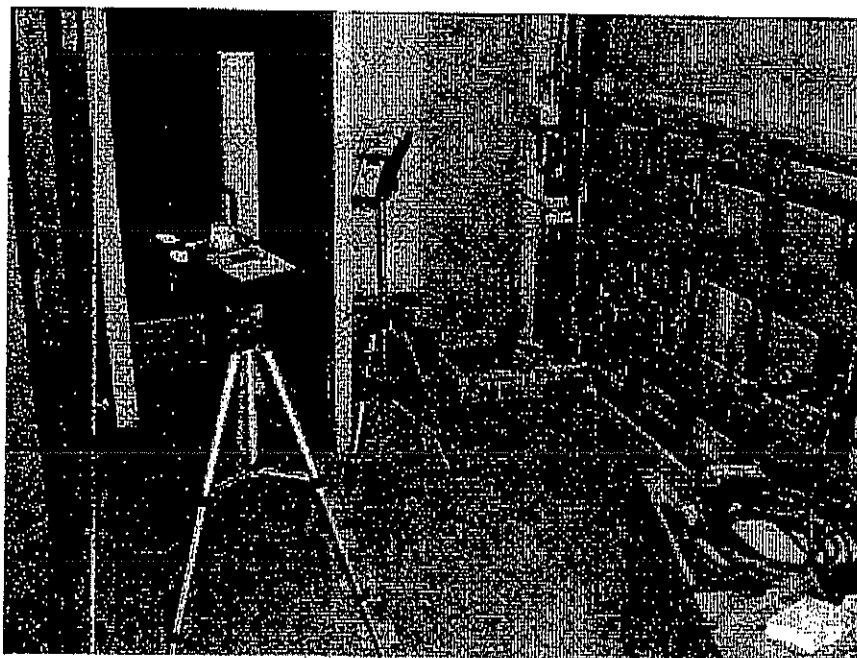
18) Image of BioMax and HTI air sampling activities performed within women's restroom containment area at time of assessment.

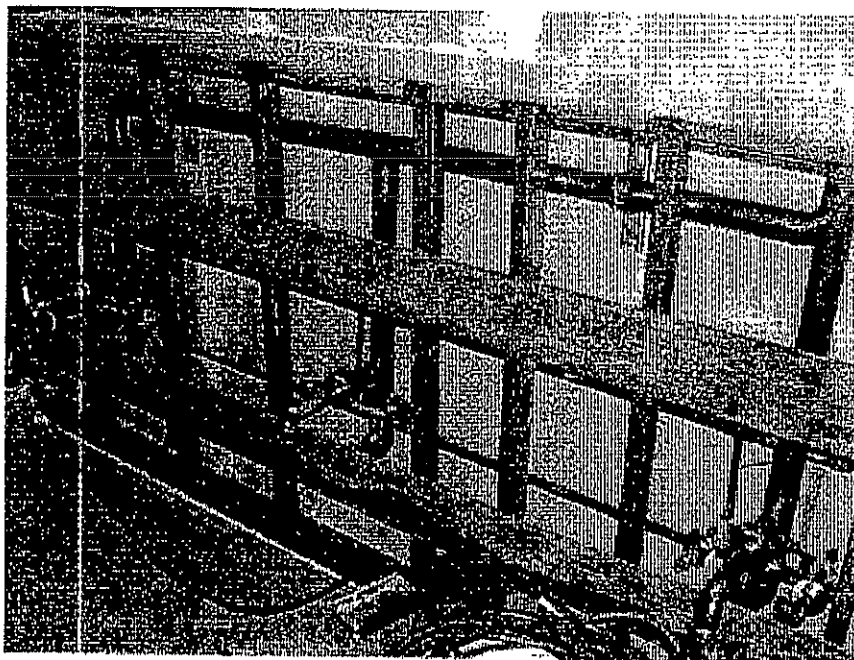
19) Image of plumbing structures and underlayment materials within women's restroom containment area at time of assessment.

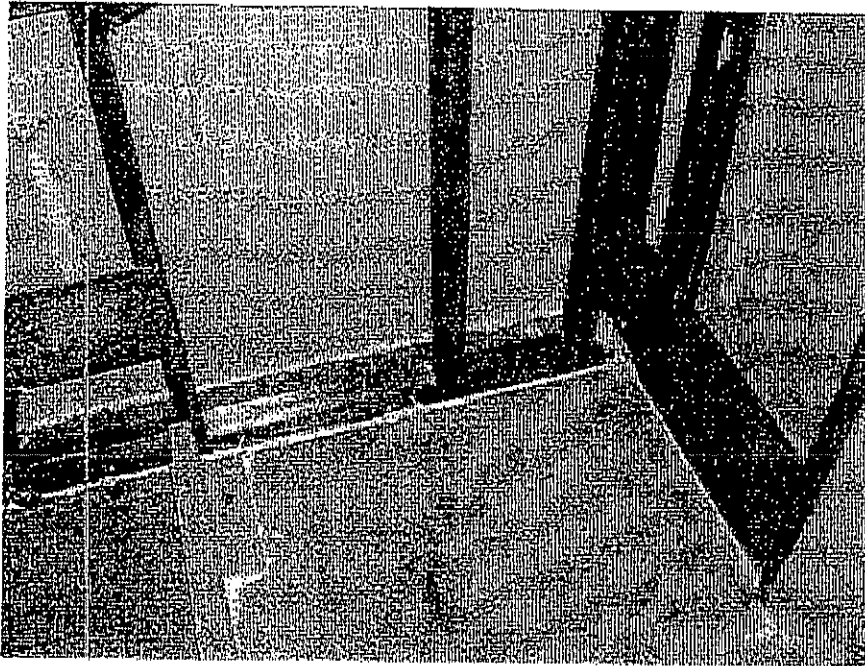
20) Close up image of exposed wallboard material to right of prior sink cabinet location of women's restroom. Absence of elevated staining noted on wall surface.

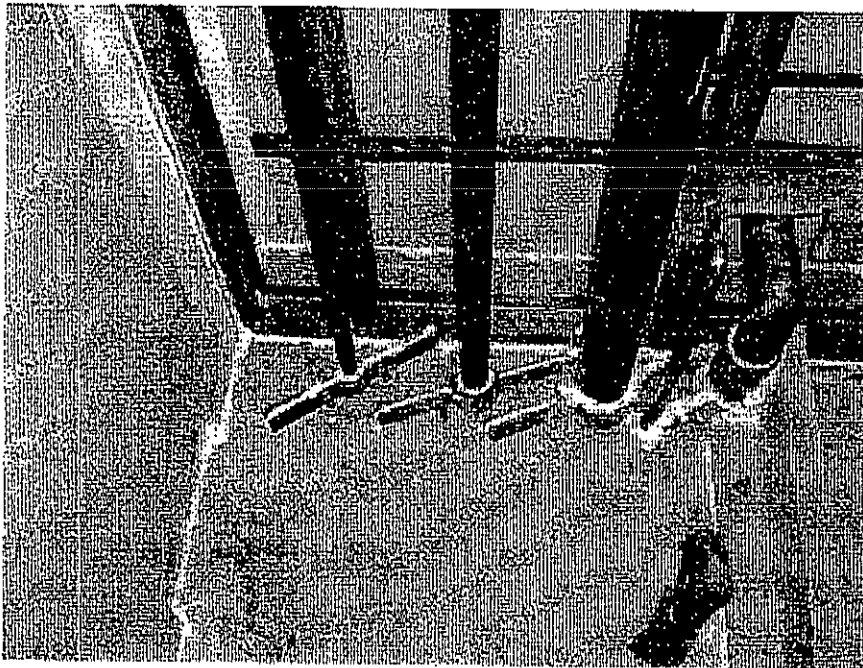
21) Image of "paper towel" cavity to left of prior sink within women's restroom area. Absence of elevated staining noted on underlayment wall surface adjacent to elevator shaft.
